# PROJECT REPORT

## CHILLIWACK FIRE DEPARTMENT, CHILLIWACK B.C.

<b>EQUIPMENT:</b>	RIC 7000
<b>PROJECT:</b>	CHILLIWACK FIRE DEPARTMENT
<b>LOCATION:</b>	CHILLIWACK B.C. CANADA
<b>PURPOSE:</b>	FOUNDATION SUPPORT

### APEX BUSINESS PARK, CORONA, CALIFORNIA

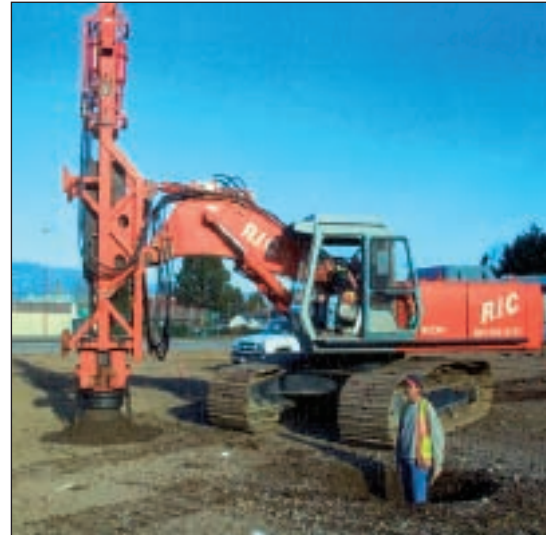
However, typical cone depth (depth of impact crater) was on the order of 3 feet, with an improvement in the blow count from 12 to 20 at a depth of 30 feet! Average overall ground deformation (subsidence) resulting from the RIC process averaged 18 inches.

Man demonstrating depth of impact crater

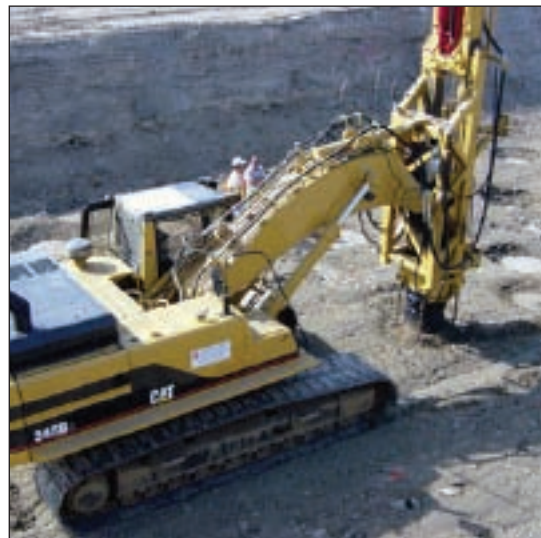
Dynamic compaction with the Rapid Impact Compactor was used to improve approximately 300,000 square feet of building pad subgrade at this Southern California commercial site.

This remedial ground improvement method addressed treatment of random fill that had been placed in an old quarry over several years.

The RIC method demonstrated its value as a "proofing" tool, with its ability to identify and simultaneously treat pockets of loose material.
